Wet-storage stain - why is it formed? How to avoid it?

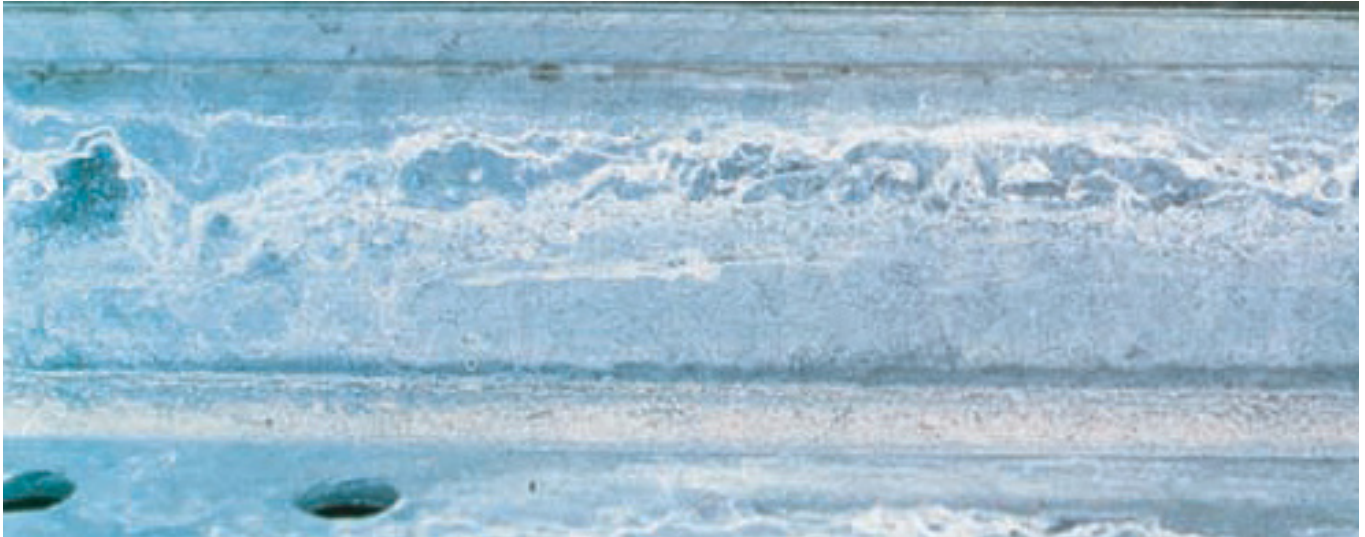
Figure 1. Wet-storage stain on closely joined angle irons after outdoor storage.

Wet-storage stain, or white rust, is the term for the white, flouly and loose corrosion products shown in Figure 1. White rust is preferably formed on newly galvanized surfaces.

White rust only forms if there is water on the galvanized surfaces, e.g. rain or condensation. If the galvanized steel are stacked tightly, the attack will primarily take place in gaps where ventilation is poor.

White rust is created due to a corrosion process, that is increased by the fact that there is relatively more oxygen at the edge of a water film or a drop of water, than in the middle. A so-called "oxygenation element" is formed because the oxygen-rich areas become nobler (cathodes) than the oxygen-poor (anodes). Such "oxidation elements" can also cause corrosion on black steel, stainless steel and aluminum.

Since this white corrosion product is very bulky (about 500 times that of the zinc from which it was formed), it can appear to be serious. Though, the white rust is normally not harmful to other of the coating's properties, and the standard for hot-dip galvanizing, EN ISO 1461: 2009, states that white rust is not cause for rejection providing the thickness of the zinc coating meets the specified minimum value.

Items with white rust are dried, e.g. by appropriate storage. The white rust attack is hereby stopped and will in time be transformed into the normal layer of zinc corrosion products, which have a protective effect.

Newly formed white rust can often be removed by washing with a stiff nylon brush and water. Minor stains with stuck white rust can be cleaned with an abrasive sponge.

White rust that has been on the zinc surfaces for a long time

becomes harder and harder to remove. Removal can here be done by gentle steel brushing. A stainless steel brush should be used to avoid the risk of iron contamination and rust discoloration.

Cleaning can also be done by brushing with dilute acetic acid, and after that proper rinse with clean water.

A white rust attack that is stopped in time does not need any finishing. If the zinc surface is measurably damaged, the workpiece can be re-galvanized or the damaged areas can be repaired using one of the methods mentioned in Nordic Galvanizer's information sheet; Repair of damage to zinc coatings.
